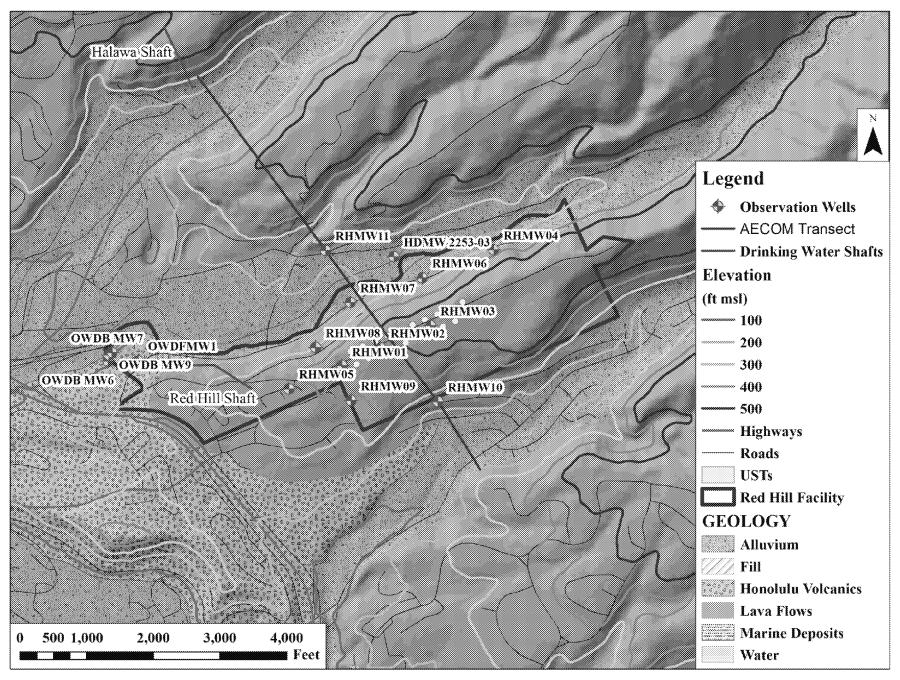
Figure A. The trace of the Work Plan Figure 3 transect is projected on a map of the geology of Oahu described by Sherrod et al. (2007). The widths of the valley fills along the transect are much less than those depicted in the Work Plan Figure 3.

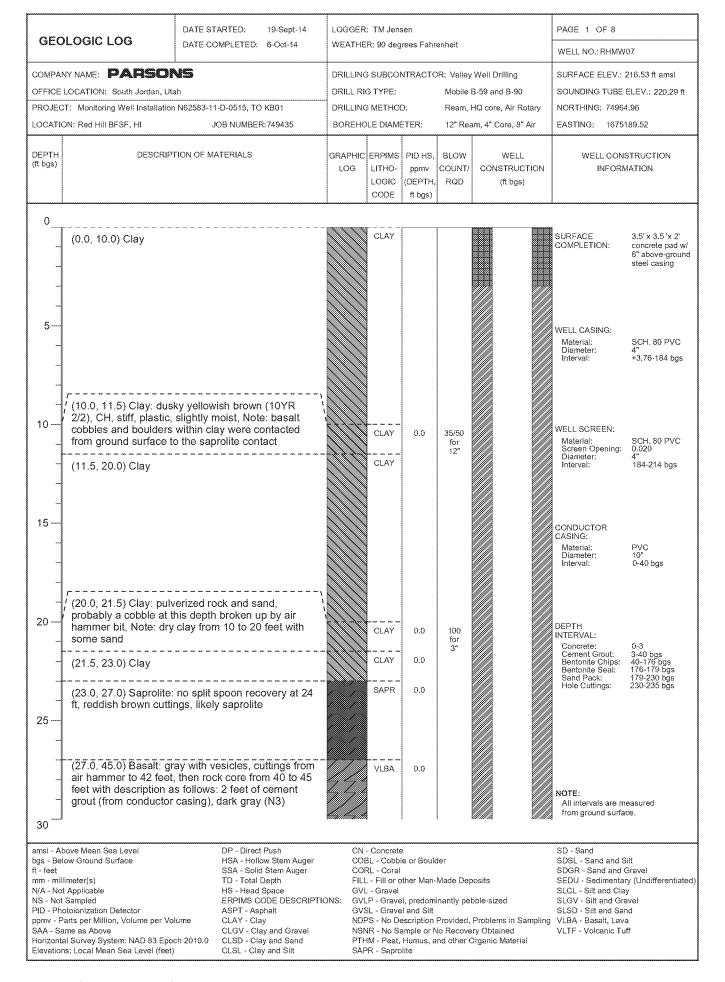
Figure B. Bore log From RHMW07

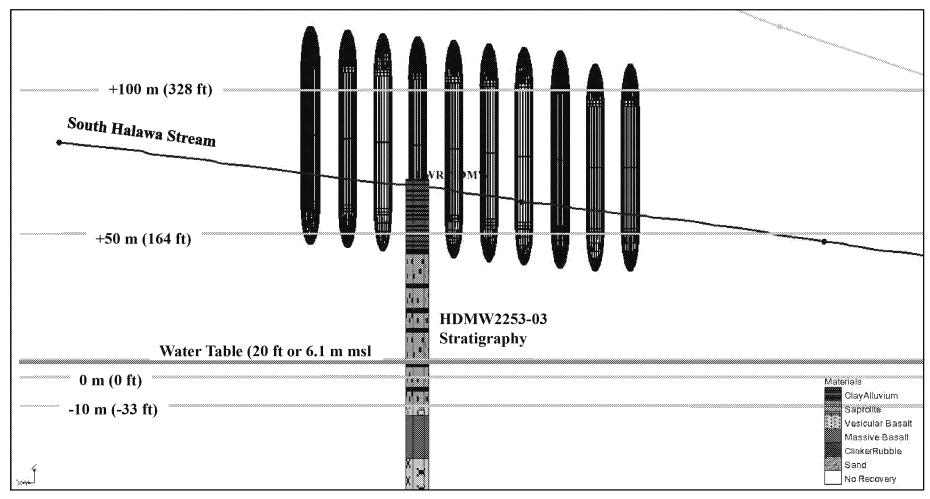
Figure C. This figure is a project cross-sectional view of the Facility looking to the southeast. It shows the USTs, the profile of South Halawa Stream, the stratigraphy of HDMW2253-03, and the elevation of the water table. The saprolite in the bore hole for HDMW2253-03 only extends to a depth of -33 ft msl. This is much shallower than suggested by the Work Plan Figure 3.
